**DEPARTMENT OF TRANSPORTATION****DIVISION OF ENGINEERING SERVICES**

Office of Structural Materials

Quality Assurance and Source Inspection

Contract #: 04-0120F4Cty: SF/ALA Rte: 80 PM: 13.2/13.9File #: 69.15**SOURCE INSPECTION REPORT****Resident Engineer:**Siegenthaler, Peter**Address:** 333 Burma Road**City:** Oakland, CA 94607**Report No:** SIR-002709**Date Inspected:** 08-Oct-2010**Project Name:** SAS Superstructure**OSM Arrival Time:** 700**Prime Contractor:** American Bridge/Fluor Enterprises, a JV**OSM Departure Time:** 1900**Contractor:** Zhenhua Port Machinery Company, Ltd (ZPMC), Changxing Island **Location:** Shanghai, China**Quality Control Contact:** Mr. Don Walton**Quality Control Present:** Yes No**Material transfer:** Yes No N/A**Sampled Items:** Yes No N/A**Stock Transfer:** Yes No N/A**OK to Cut:** Yes No N/A**Rebar Test Witness:** Yes No N/A**Delayed/Cancelled:** Yes No N/A**Other:** Coating Inspection**Bridge No:** 34-0006**Component:** See Below**Bid Item:** 77, 78, 79**Lot No:** B #204**Summary of Items Observed:**

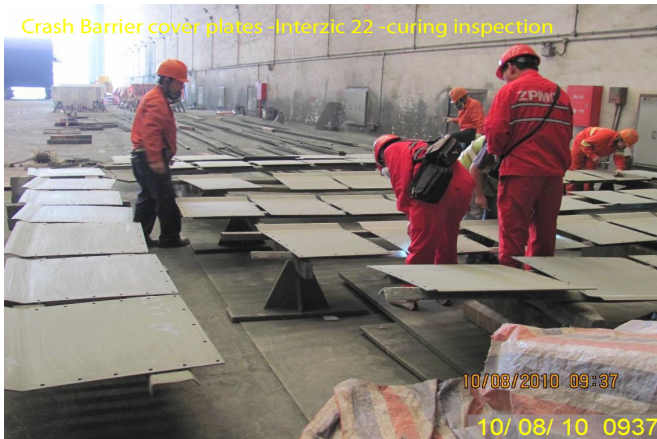
Crash Barrier cover plates -Interzic 22 -curing inspection

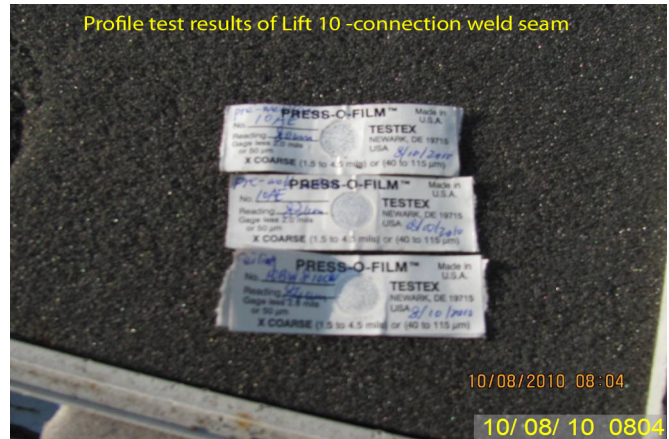
An inspection was requested on the OBG Segment, 10 AE, Pre weld seam entire internal surface and connection weld seam internal ceiling part between 10BW & 10CW, vide inspection request no. 4529 at OBG assembly yard.. This QA inspector observed, ABF Inspectors Mr. Stone, Mr. Turtle and Mr. Vince inspecting these surfaces for surface profile as per SSPC SP 10. This QA inspector observed, surface profile measured by ZPMC QC inspectors found to be in the range of 80 to 84 microns which is acceptable as per contract Documents. International protective coatings technical service representative Mr. Yang was found present during the course of this inspection process.

Profile test results of Lift 10 -connection weld seam

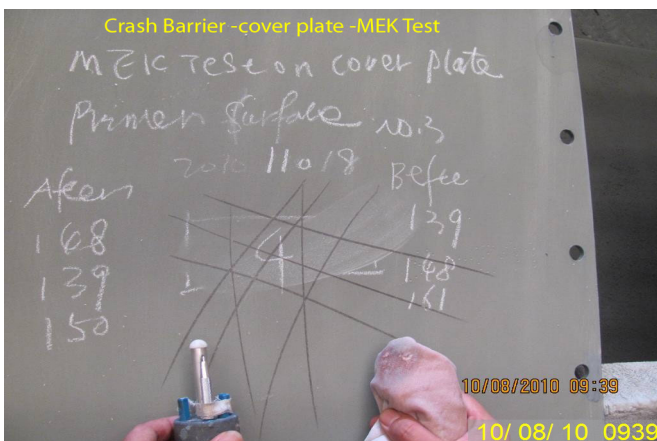
inspector Mr. Turtle and Mr. Vince performing the required inspections. The MEK test found to be carried out in 3 places and the result observed as Grade 5 in 2 places and Grade 4 in 1 place. The Result of Residual chloride test carried out in 1 place found to be 13.2 us/cm. The result of Salt test and MEK tests found to be acceptable as per contract documents. International protective coatings technical service representative Mr. Yang, was found present during the course of this inspection process.

Crash Barrier -cover plate -MEK Test
